Client(s): **Town of Thetford VT**

Property address: **Treasure Island Facility**

Inspection date: **Friday, November 14, 2014**

Property Inspection Report

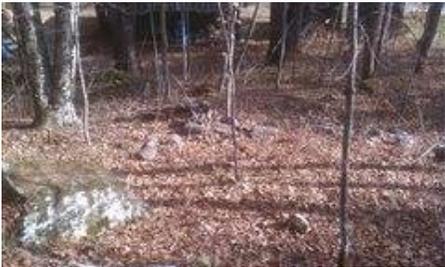
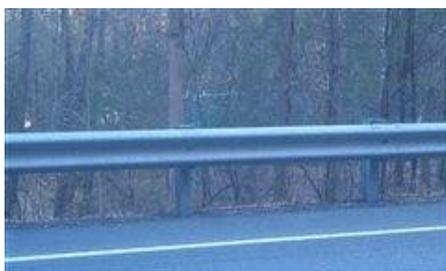
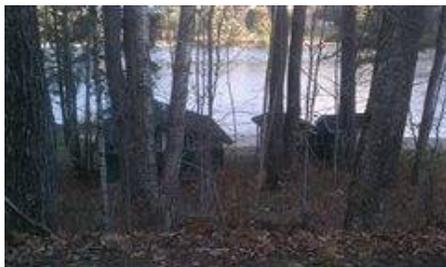
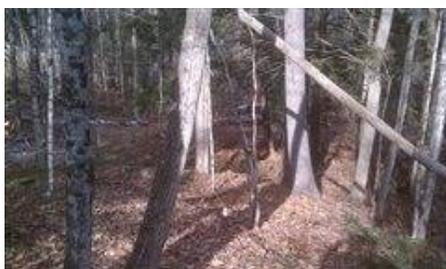
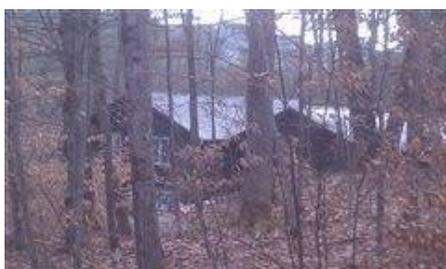
The entire property has an abundance of dead or damages trees, brush and brush piles, new and old brush growth, some of the dead standing trees are a safety concern especially around the public buildings and public areas of the property

looking down from driveway to bathhouse,
overgrowth from saplings, brush

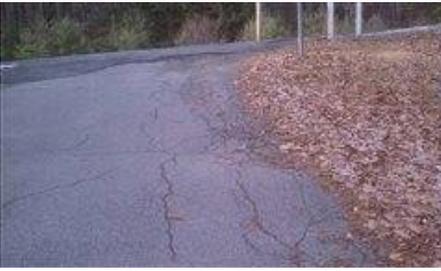
Driveway needs some repairs,

Photo 2-1
driveway cracked and sunken

remove and patch sunken and heaved areas

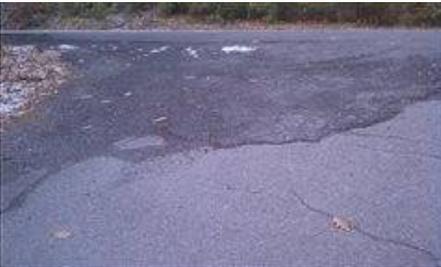
Photo 2-2
portion of driveway near RT 244 needs
repair from town construction

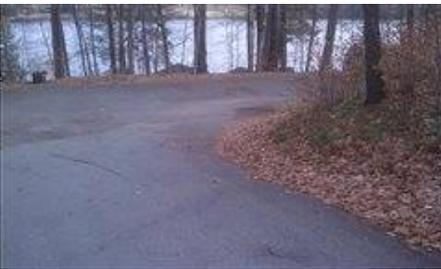
- **Minor deterioration** (e.g. cracks, holes, settlement, heaving) was found in the driveway, but no trip hazards were found. The client may wish to have repairs made for cosmetic reasons.

Recommend: that a qualified contractor evaluate and repair as necessary. For example, removing old pavement and installing new.

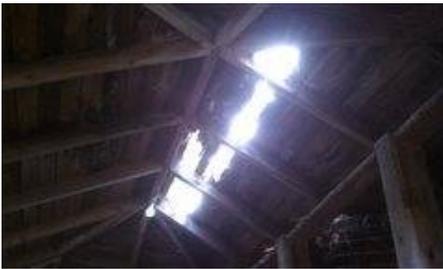
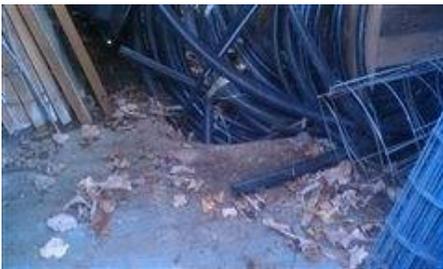
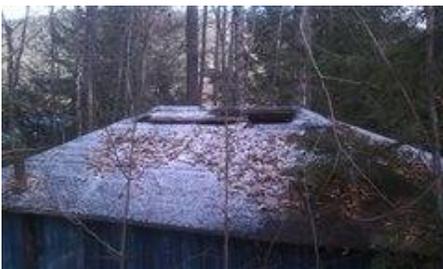
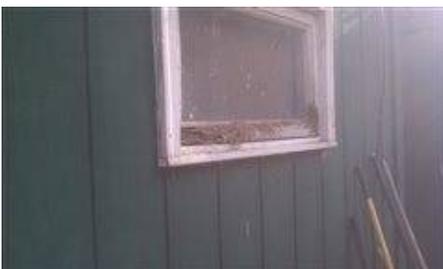
The beach equipment storage building located on the beach needs the rear window sill replaced due to rot

window on back of beach equipment

repair holes in floor and roof

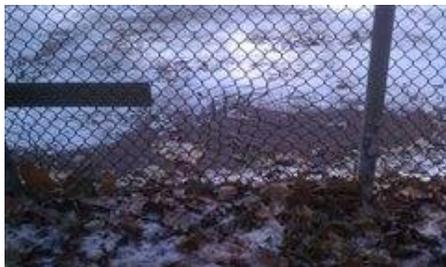
Fencing on the volleyball and basketball courts need repair, some of the posts need to be reset

Photo 6-1
hole in volleyball court fence

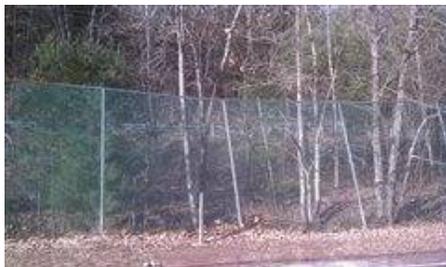
Photo 6-2
fence on volleyball court leaning out

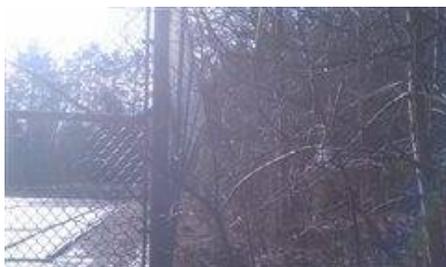
Photo 6-3
fence on volleyball court leaning out,
needs trees and brush cleared

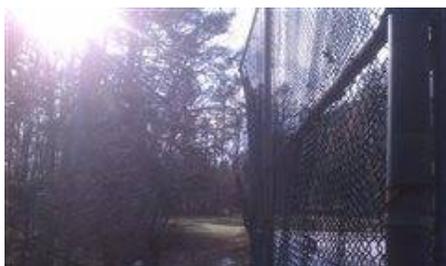
Photo 6-4
volleyball court fence leaning

- Fencing on the volleyball and basketball courts need repair, some of the posts need to be reset

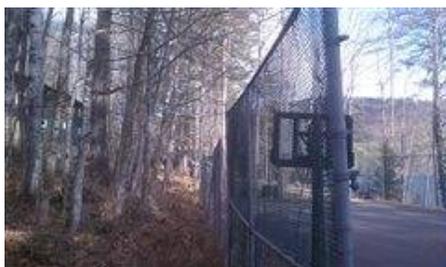
Photo 6-5
basketball court fence leaning in and out

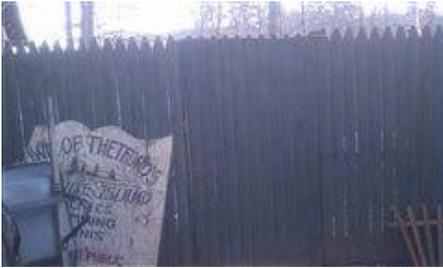
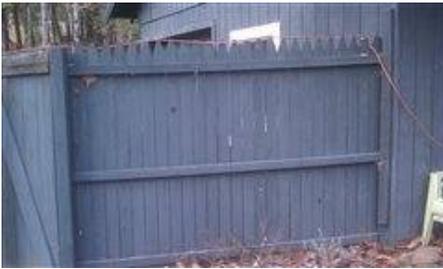
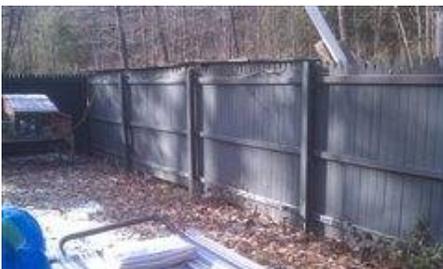
7) **i** fencing in back yard attached to house is in good working condition

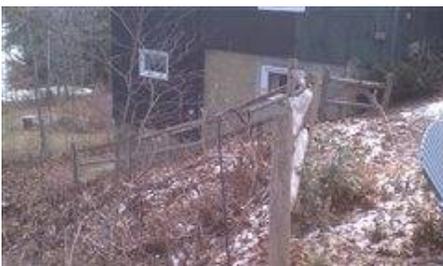
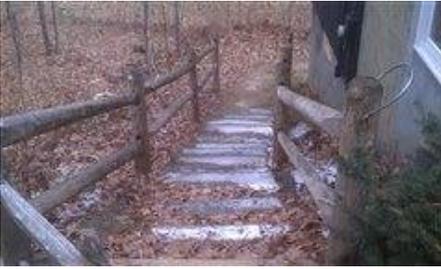
8) **i** The post and rail fence located on the stairs going to the beach is in good condition no signs of wear or rot

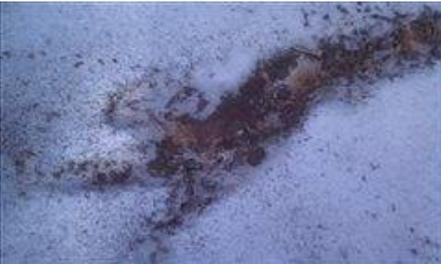
**Photo 9-1**

basketball court needs holes filled due to settling gravel under blacktop, volleyball court has some water erosion due to drainage of upper slope of property facing RT 244, needs to be filled and re-compacted, volleyball court retains water and makes it very unstable

erosion on volleyball court due to road drainage

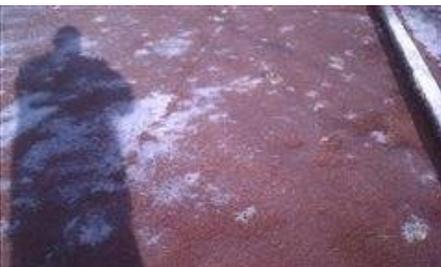
**Photo 9-2**

puddling water on volleyball court

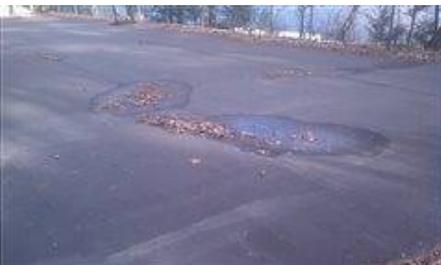
**Photo 9-3**

dips in basketball court, also needs lines painted

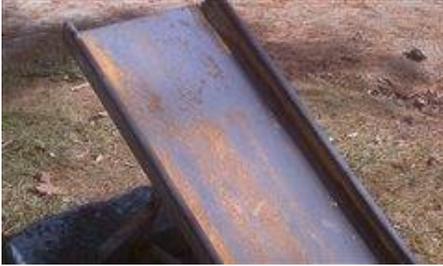
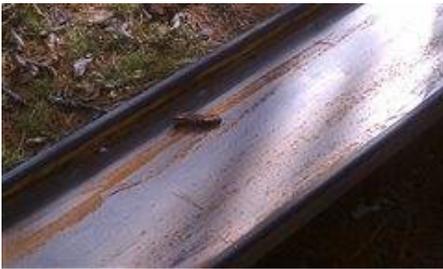
The metal slide on the beach is rusted dangerous and out of date

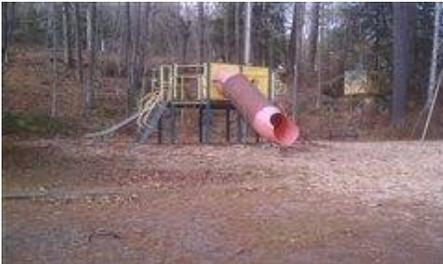
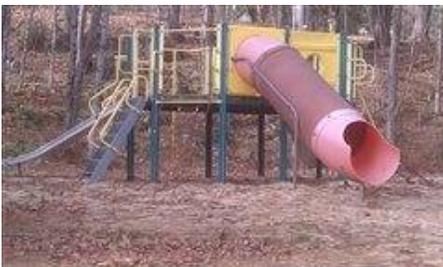
outdoor jungle gym on the beach, The fall distance from floor to ground should be within 4" or less, need to fill under play set a few inches for the safety of the children

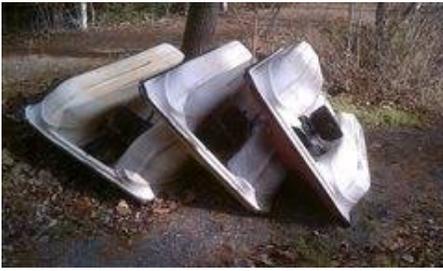
Photo 12-1
paddle boats in good working condition

The condition of the boats used publicly are all in good working condition

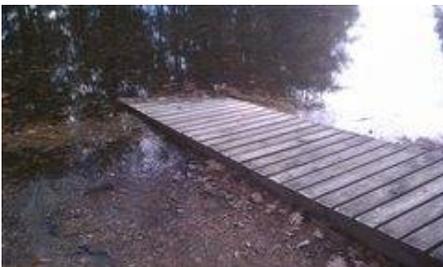
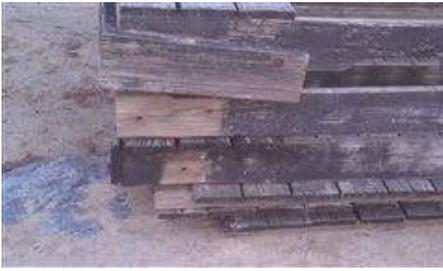
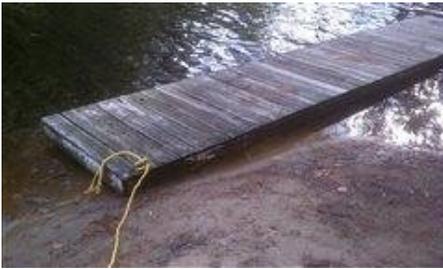
The two floating boat docks on the main beach area are showing signs of wear, and are in need of repair,

The floating dock in cove area should be pulled out and evaluated for rot and maintenace

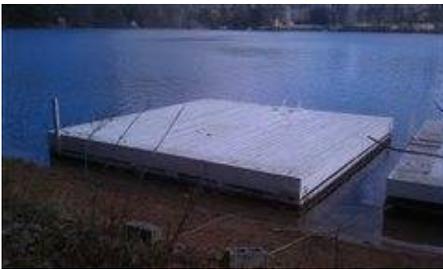
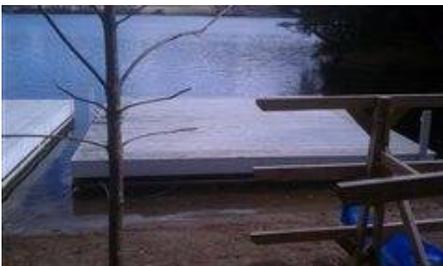
The two floating platforms are in good working condition, no signs of rot

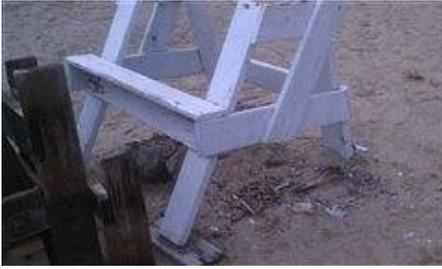
Photo 15-1

The lifeguard station chair is in the process of being rebuilt due to rot, the footing for chair need replacing should be replaced with concrete block

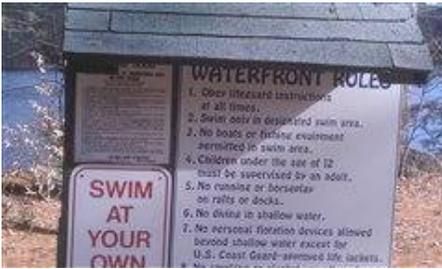
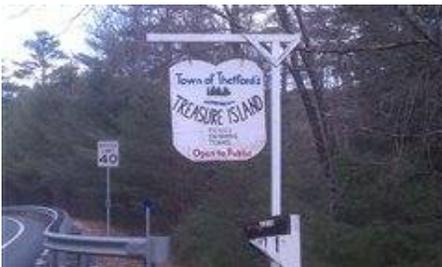
All signage for park is in good condition and adequate

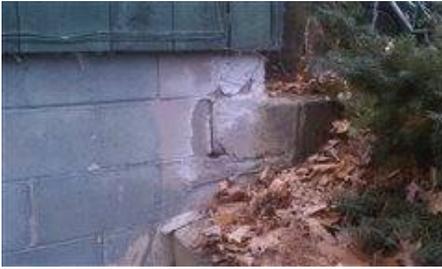
**Photo 17-1**

Moderate cracks (1/2 inch - 3/4 inch) were found in the foundation. This may be a structural concern or an indication that settlement is ongoing. The client should consider hiring qualified contractors and/or engineers as necessary for further evaluation. At a minimum, recommend sealing cracks to prevent water infiltration. Numerous products exist to seal such cracks including hydraulic cement, resilient caulks and epoxy sealants.

A concrete block cracked a joints and mortar missing

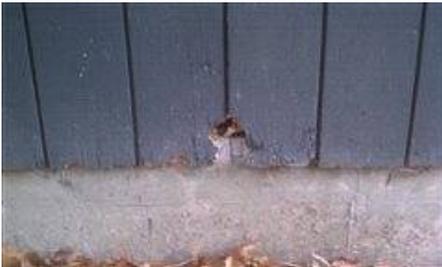
**Photo 18-1**

One or more holes or gaps were found in siding or trim on the attached garage. Vermin, insects or water may enter the structure. Recommend that a qualified person repair as necessary.

hole and rot on side of the garage facing RT 244

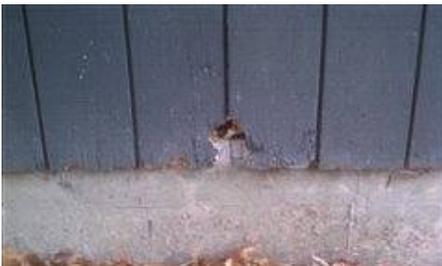
**Photo 20-1**

- 20) Garage is in good shape overall, except the side wall facing RT 244 has some rot and a hole at the base of the siding

hole and rot on side of the garage facing RT 244

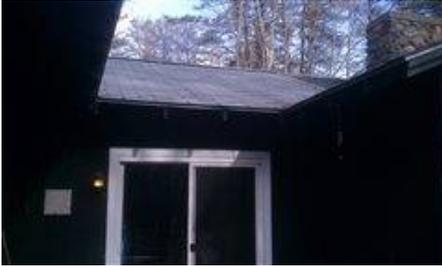
Gutters were missing over one or more entrances. People entering and exiting the building are likely to get wet during periods of rain as a result. Most buildings benefit from having a complete drainage system installed, but at a minimum, recommend installing gutters over entrances.

Photo 21-1
missing gutters over entances

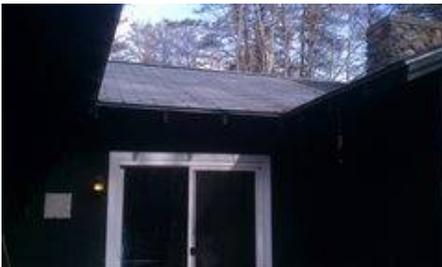
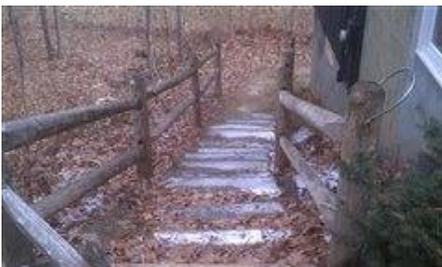
One or more gutters and/or downspouts were missing. Rainwater can come in contact with the building exterior or accumulate around the building foundation as a result. This is a conducive condition for wood-destroying organisms. Recommend that a qualified person repair as necessary.

erosion is taking place between the house and stairs going down to beach area due to no gutters on house or garage at main entrance to home

Photo 22-1
missing gutters over entances

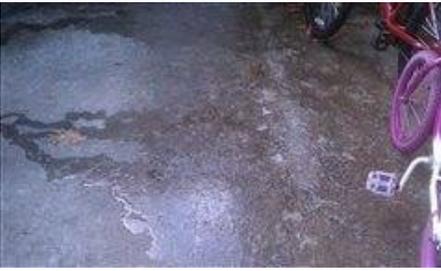
**Photo 23-1**

main entrance patio slab forms ice creating very serious slippery conditions due to missing gutter over and around main entrance

main entrance patio with ice formed at entrance due to gutters missing over entrances

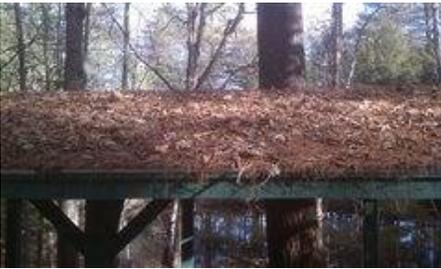
**Photo 24-1**

although not a safety concern, roofs on all building on the property should be power washed to remove moss and algae build up,

open patio structure at Island point, covered in moss as well as foliage from trees

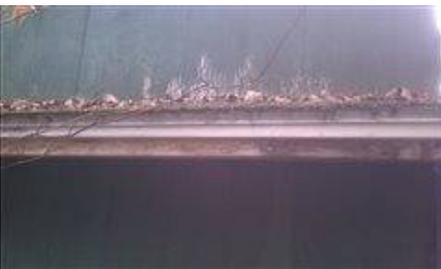
**Photo 24-2**

- Significant amounts of debris such as leaves, needles, seeds, etc. have accumulated on the roof surface of a good portion of the out buildings. Water may not flow easily off the roof, and can enter gaps in the roof surface. Leaks can occur as a result. This is a conducive condition for wood-destroying organisms. Recommend cleaning debris from the roof surface now and as necessary in the future.

shed roof on back of storage facility on beach moss and debris build up

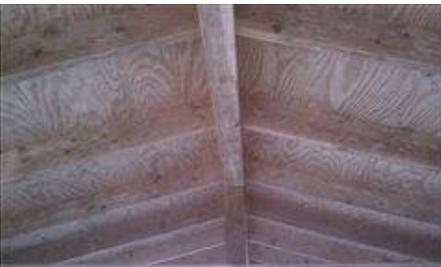
**Photo 24-3**

underneath roof structure, unprotected from weather condition and moisture

some of the roofed structures have unprotected rafters and roof plywood underneath, **recommend** staining or painting for preservation purposes

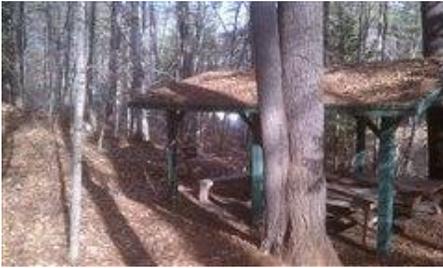
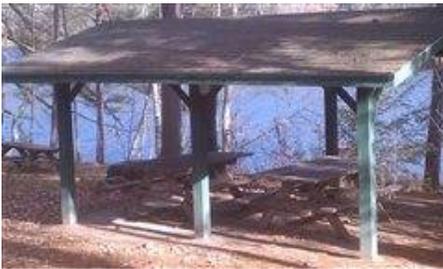
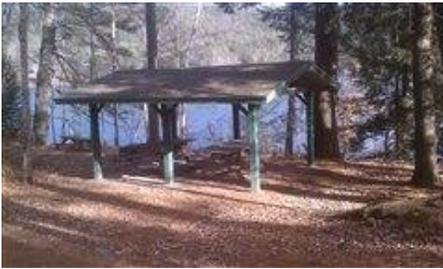
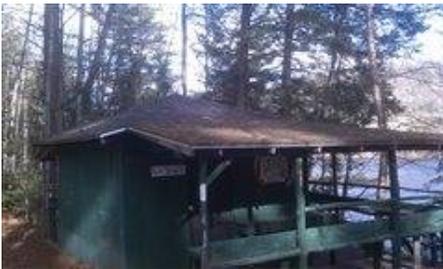
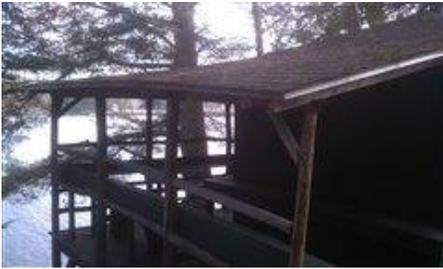
Significant amounts of debris such as leaves, needles, seeds, etc. have accumulated on the roof surface of a good portion of the out buildings. Water may not flow easily off the roof, and can enter gaps in the roof surface. Leaks can occur as a result. This is a conducive condition for wood-destroying organisms. Recommend cleaning debris from the roof surface now and as necessary in the future.

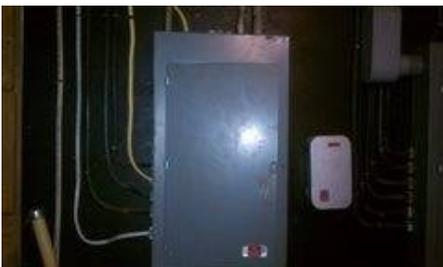
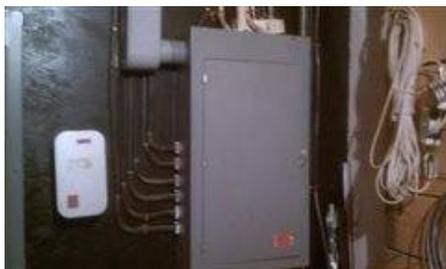
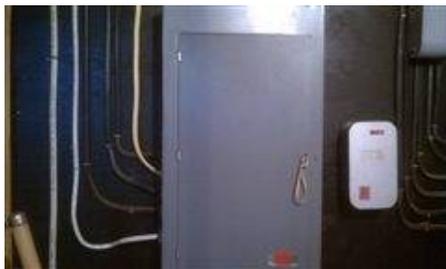
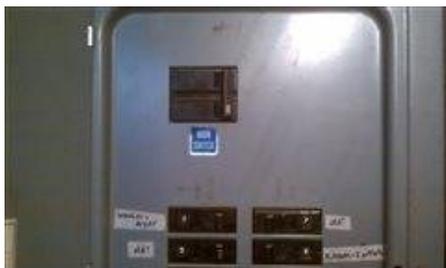
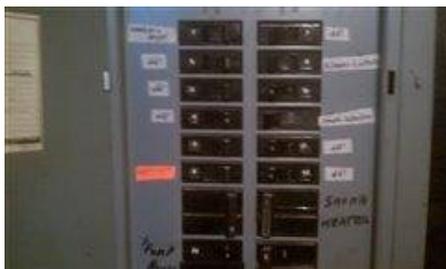
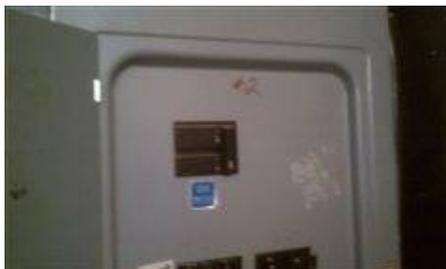
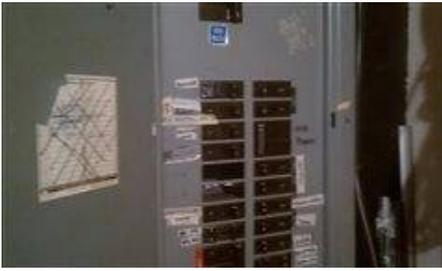
**Electrical Panels:**

all electrical panels and connections are up to date materials and are all in working order, free from defects and moisture,

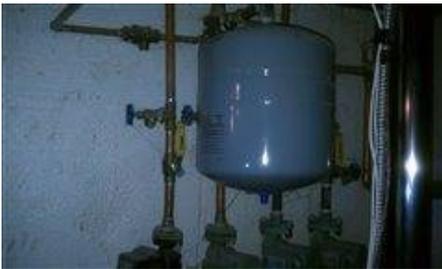
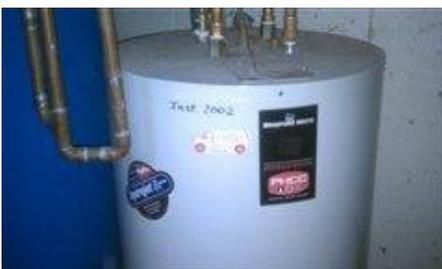
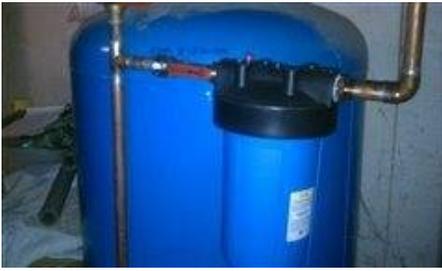
28) water heating system

Bradford White system professionally installed in 2002 with an over sized filtered water holding tank, system seems to be up to date and in good working condition

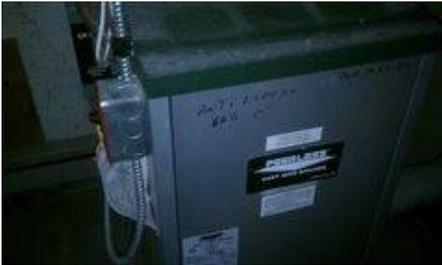
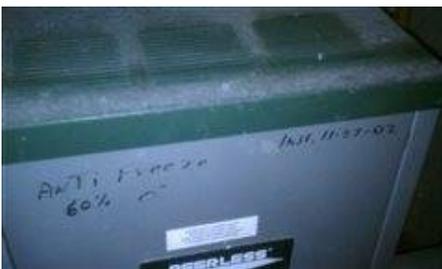
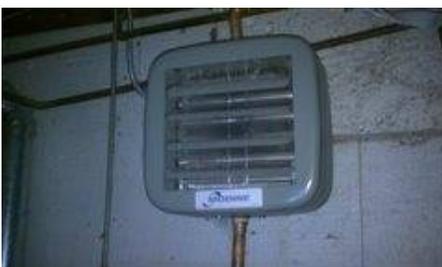
29) Heating System

Peerless cast iron propane fired boiler system professionally installed in 2002 system is in good working condition

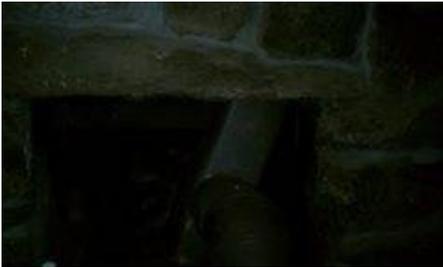
Photo 30-1

there are two back to back fire places as well as an older fisher wood stove connected into one of the 3 chimney flues, the fire place on the den side of the chimney is blocked off the flu is in-operable, chimney is missing flu caps/covers

secondary heat source vent pipe securely and safely connected to the second flu in the chimney

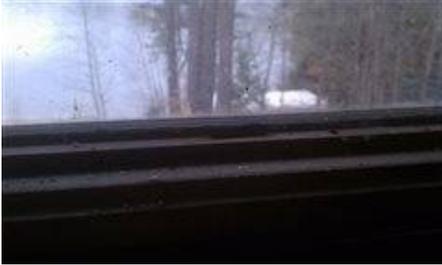
Photo 31-1

overall condition and useability of the kitchen is adequate but does need to be remodeled, the cabinet and cooking space is of inadequate size, kitchen window is single pane and should be replaced, appliance all work well, there is also a kitchen light right over the sink which is very hazardous

kitchen window is single pane and should be replaced

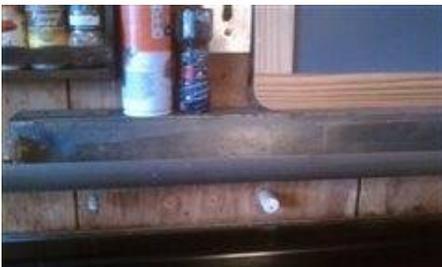
Photo 31-3

unprotected light fixture right over the kitchen sink

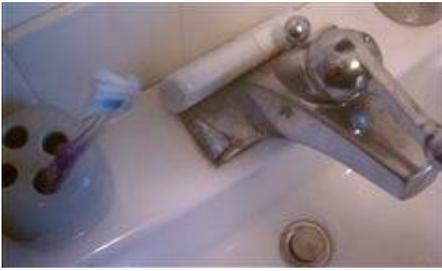
bathroom sink faucet needs replacement

Photo 33-1
bathroom faucet housing broke

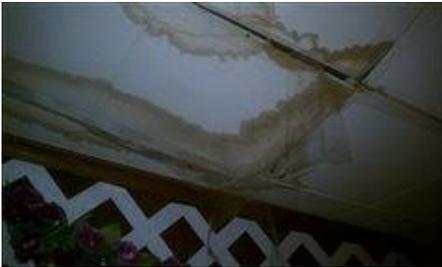
Photo 34-1

- 34) 🟢🔪 The ceiling in the master bedroom is in need of repair since roof was replaced

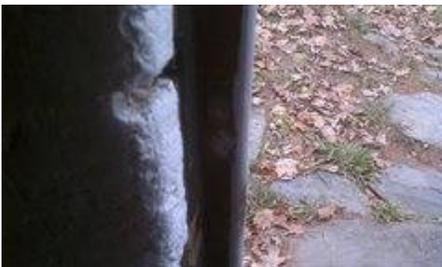
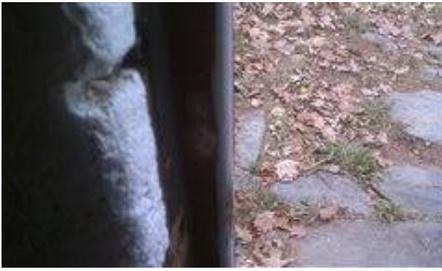
- 35) 🧤✅ Basement door needs new weather stripping
